ANNUAL REPORT FOR 2002

Wiggins Mill Mitigation Site
Wilson County
Project No. 8.1330509
TIP No. R-1030WM

Office of Natural Environment & Roadside Environmental Unit
North Carolina Department of Transportation
December 2002/ Revised March 2003

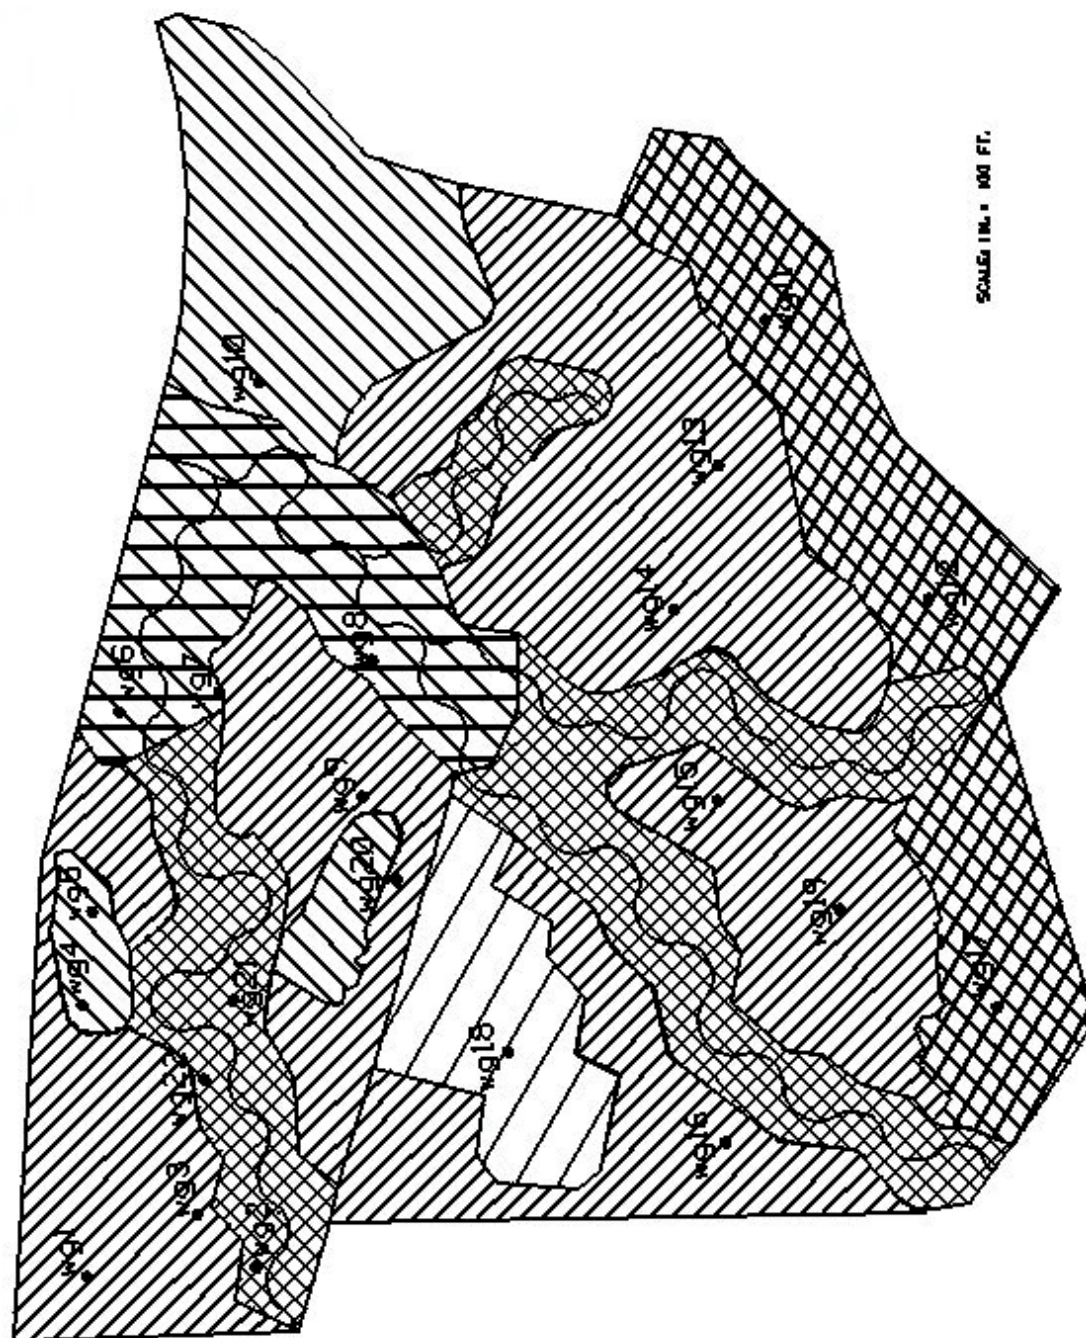
Figure 2. Wiggins Mill Site Gauge Location Map

Eighteen monitoring gauges were installed on site in March of 2001 (Figure 2). Four additional groundwater gauges were installed on site in spring 2002, (WM-G19, WM-G20, WM-G21, WM-G22). These gauges were installed, based on the agency review meeting, in between marginal gauges and gauges that failed to meet success criteria in 2001.

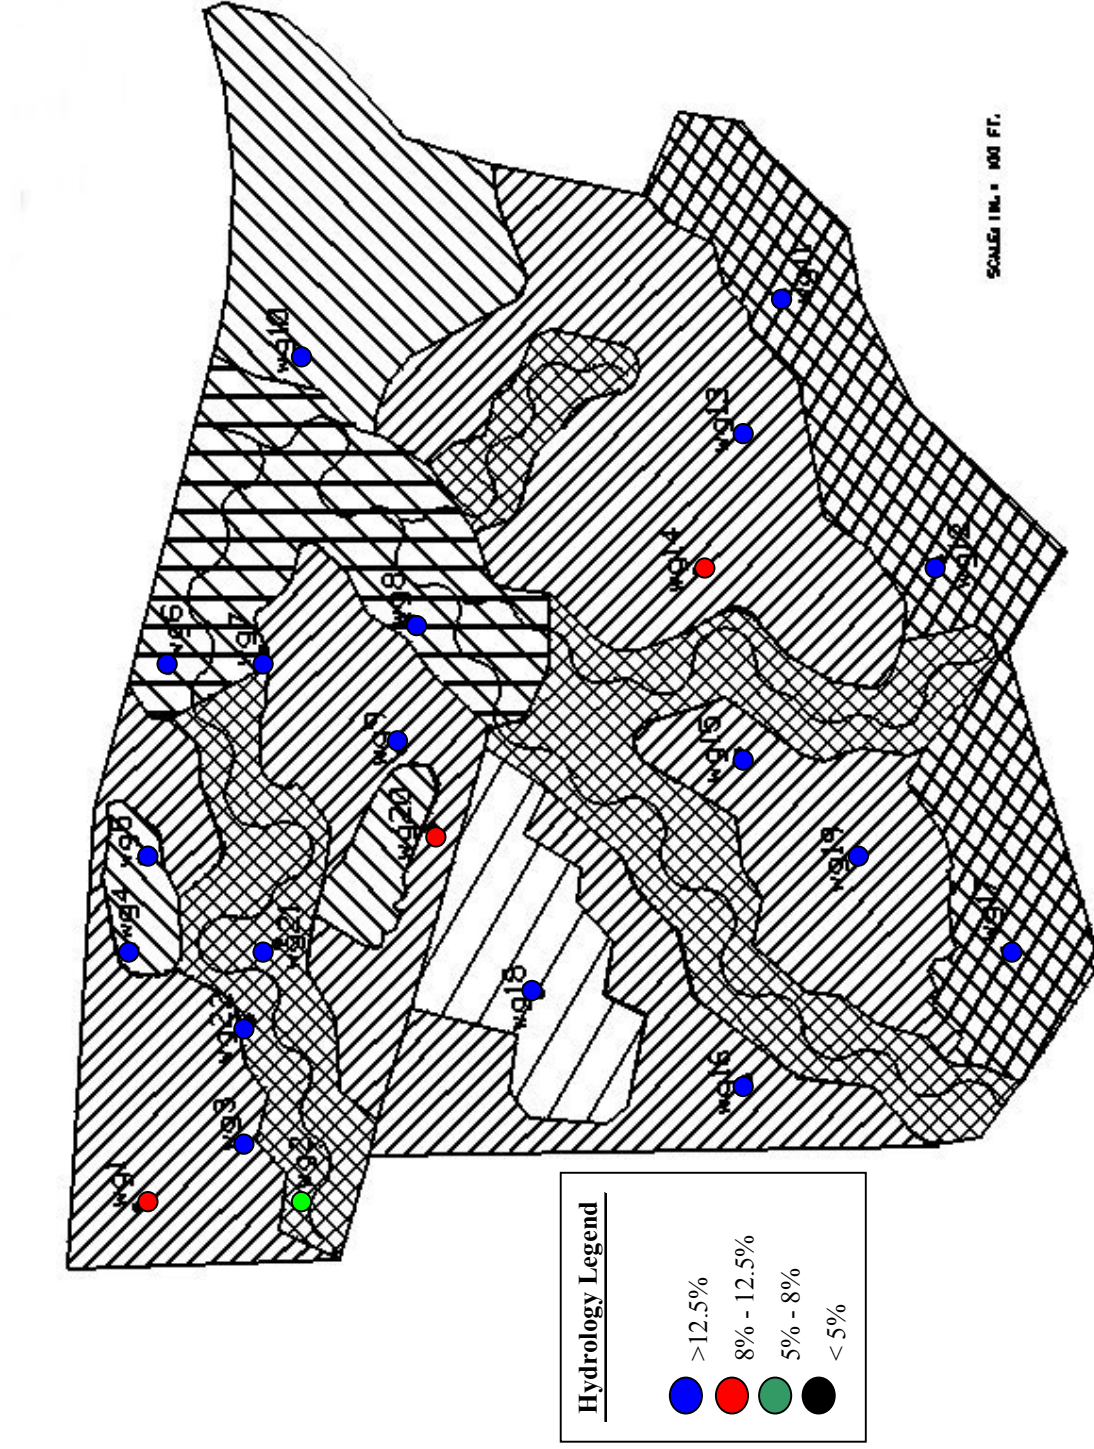
Figure 3. 2002 Wiggins Mill Site Hydrologic Monitoring Results

Figure 3 represents a graphical representation of the hydrologic results. Gauges highlighted in blue indicate wetland hydrology for more than 12.5% of the growing season. Gauges highlighted in red show hydrology between 8% and 12.5% of the season, while those in green indicate hydrology between 5% and 8% of the season. Gauges highlighted in black indicate no wetland hydrology (less than 5% of the growing season).

The year 2002 is the second full year of hydrologic monitoring for this site. All 22 monitoring gauges met the success criteria showing saturation for more than 5% of the growing. Eighteen of the twenty-two gauges showed saturation for 12.5% of the growing season, 3 of the gauges showed saturation between 8 and 12.5% of the growing season, and 1 of the gauges showed saturation between 5 and 8% of the growing season. The site experienced below normal rainfall yet met hydrologic success criteria for the second year of monitoring.

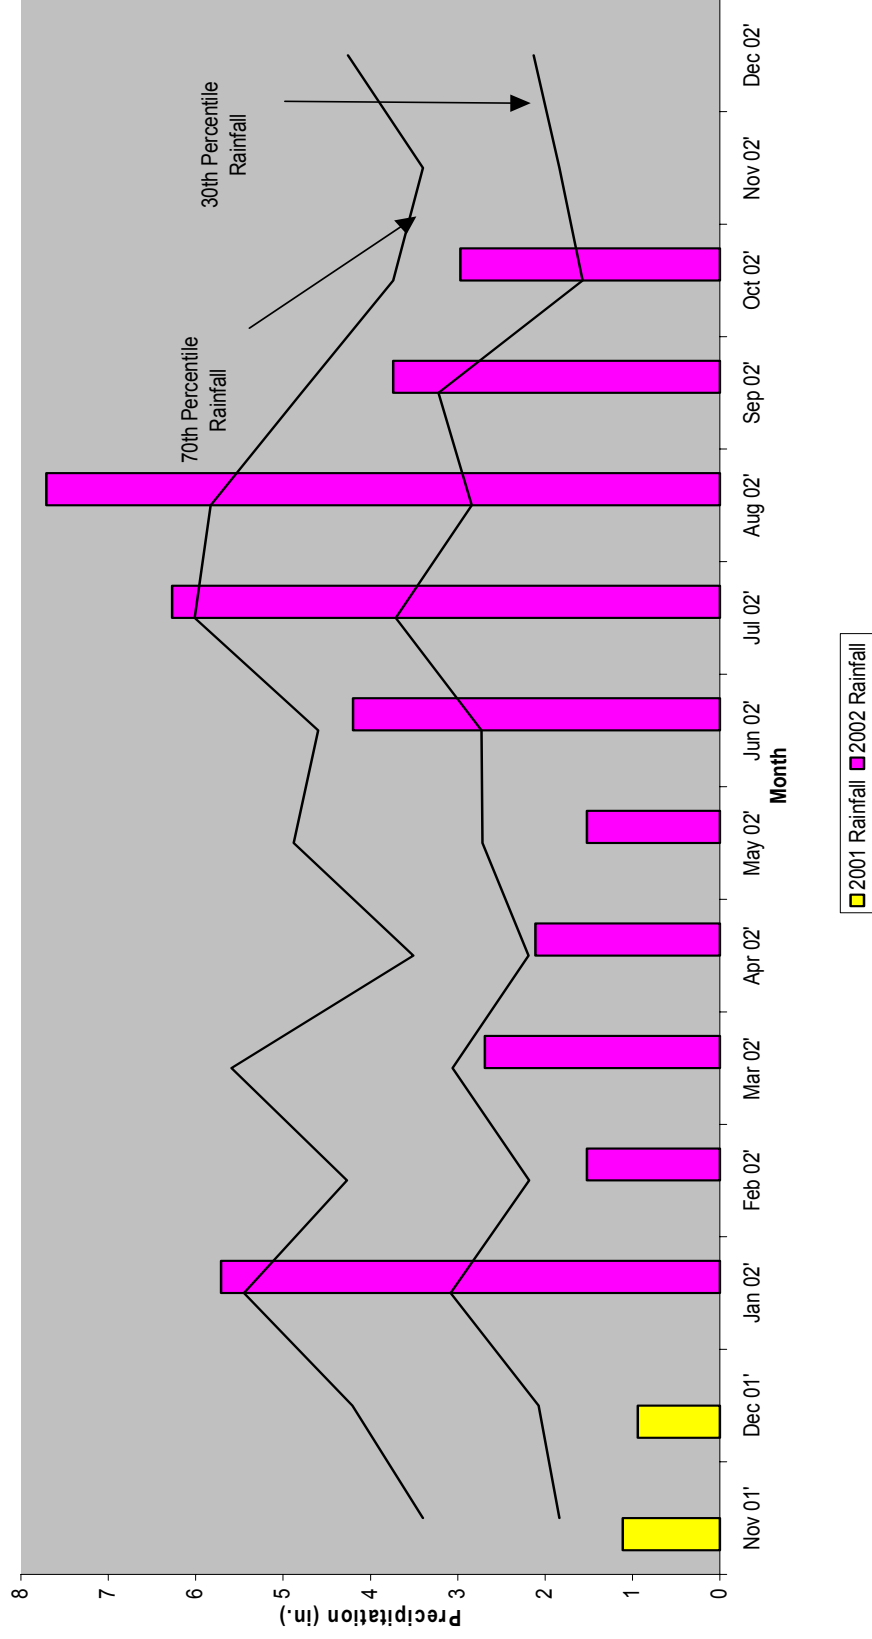
Figure 4, Wiggins Mill 30-70 Graph
Wilson, NC

Figure 4 is a comparison of monthly rainfall for the period of November 2001 through October 2002 to historical precipitation (collected between 1970 and 2002) for Wilson, North Carolina. This comparison gives an indication of how 2002 relates to historical data in terms of average rainfall. The NC State Climate Office provided all historical data.

Monthly rainfall for the site fluctuated around the average rainfall for 2002. November (2001), December (2001), February, March, April, and May experienced below average rainfall. The months of June, September, and October all recorded average rainfall for the site. January, July and August experienced above average rainfall. Overall, the site experienced below average rainfall for 2002.

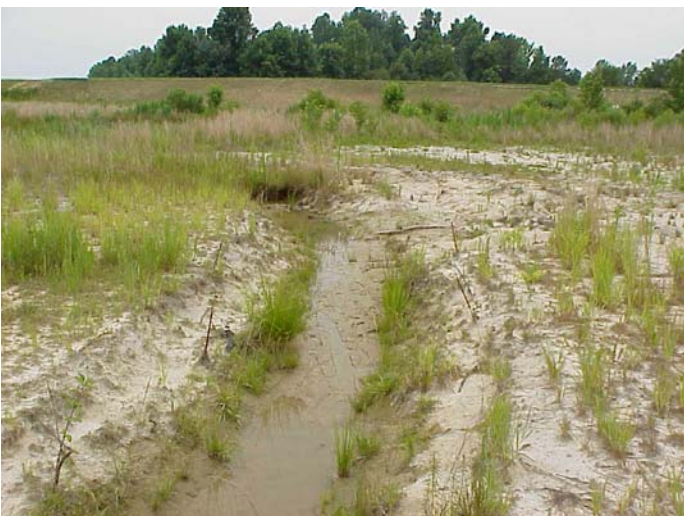
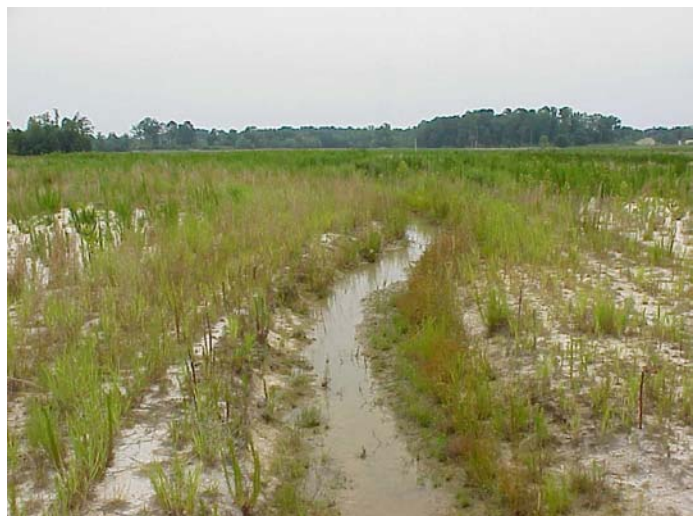
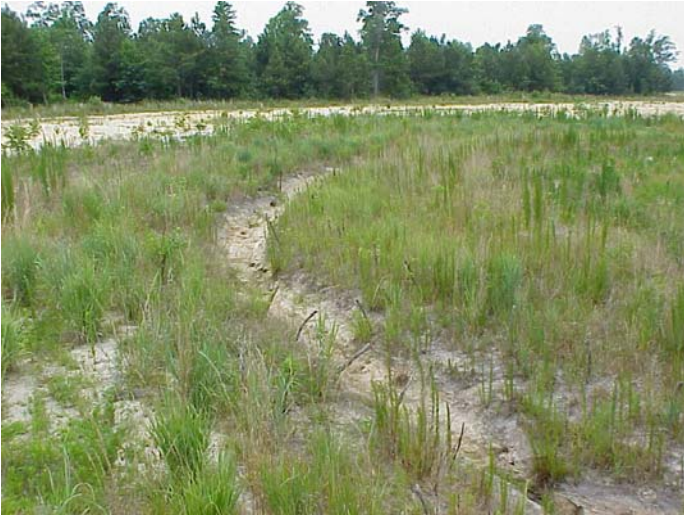
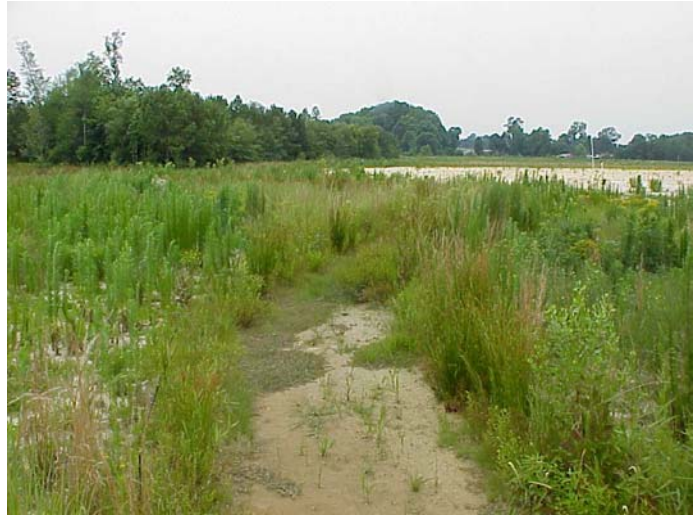
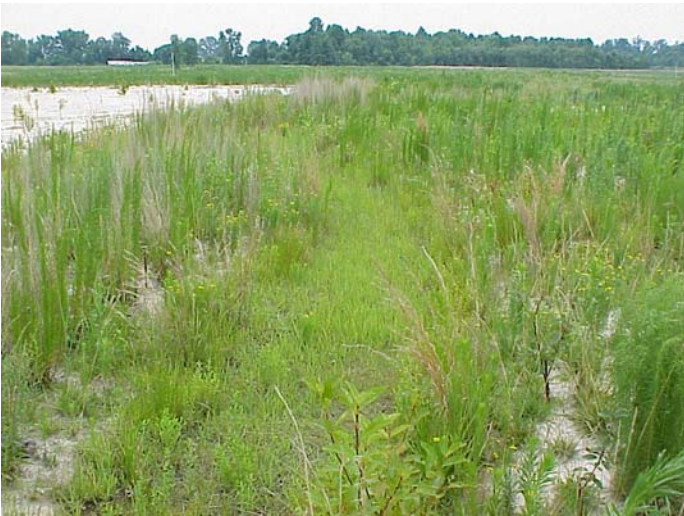
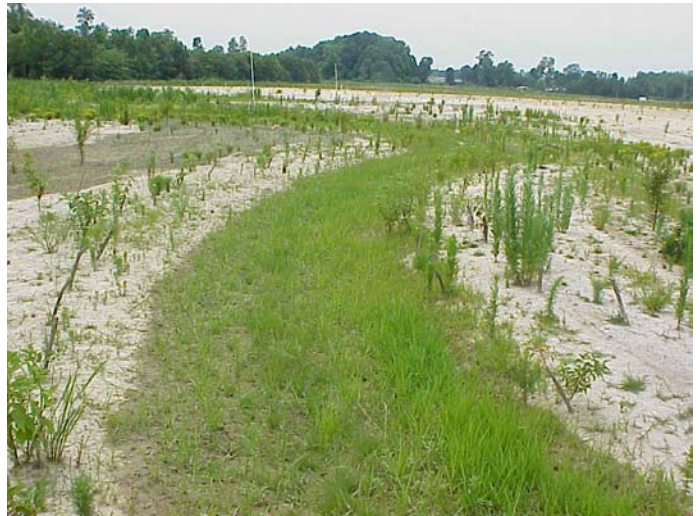
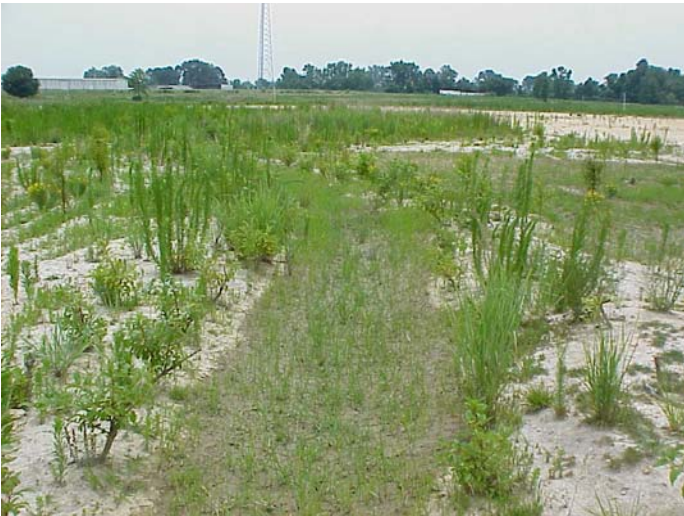
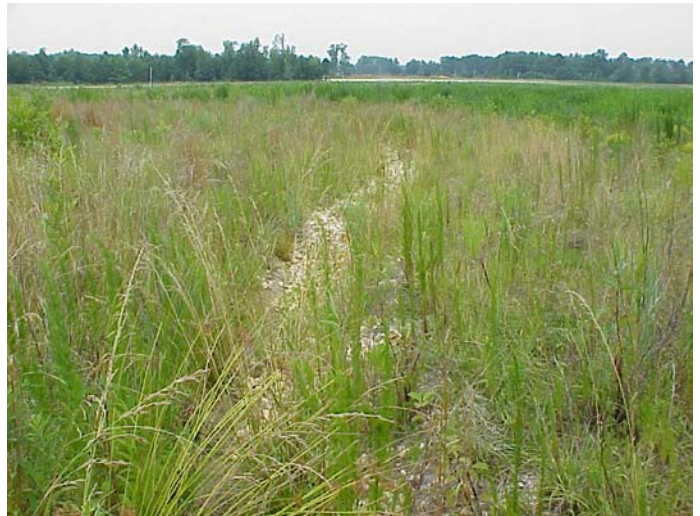
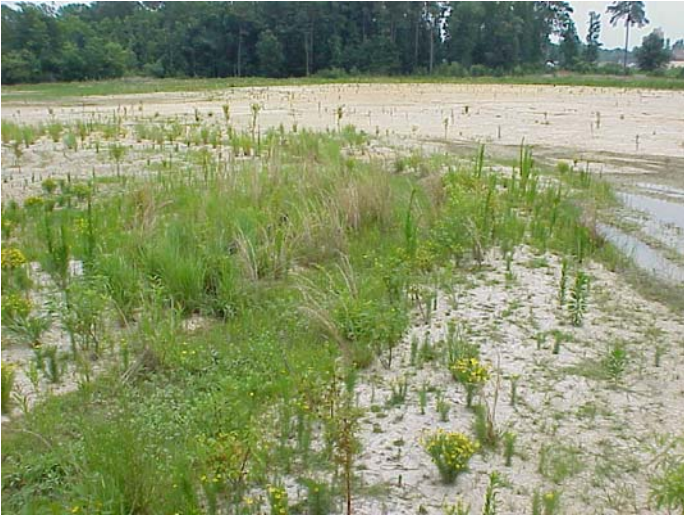
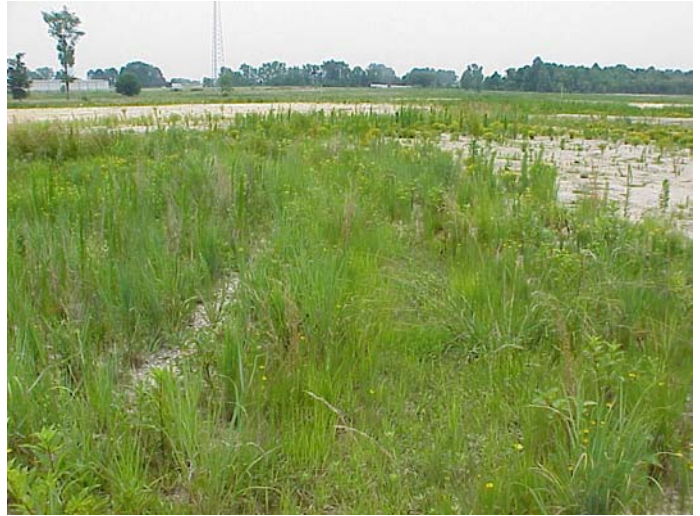
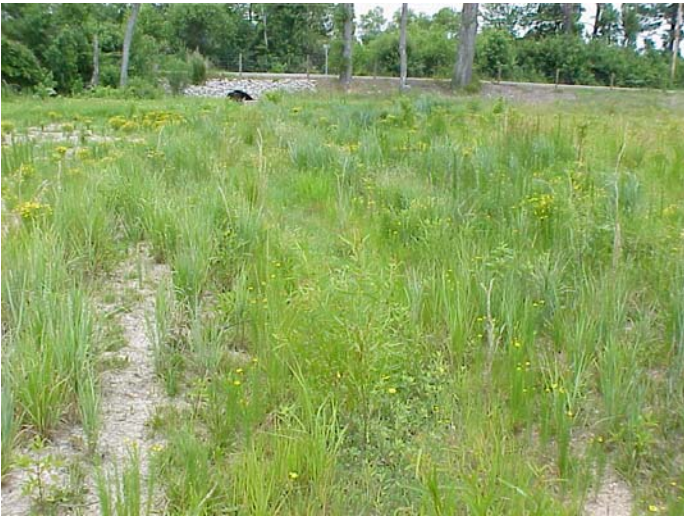
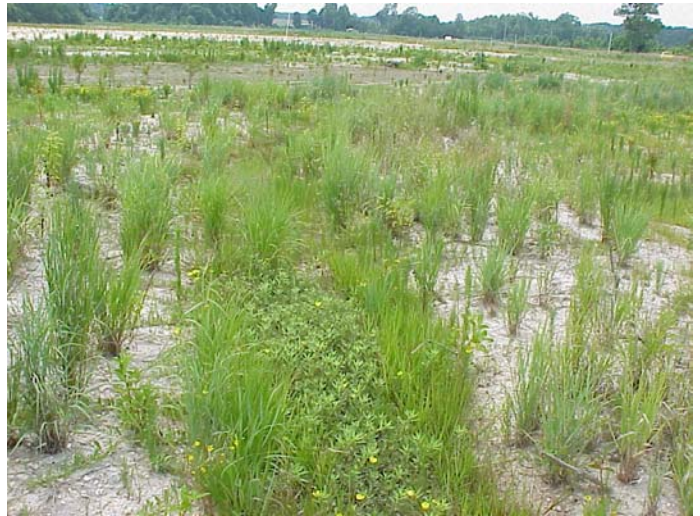
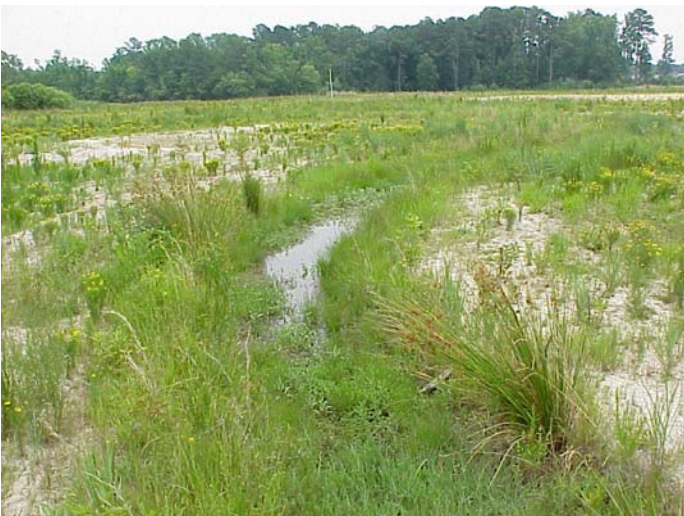
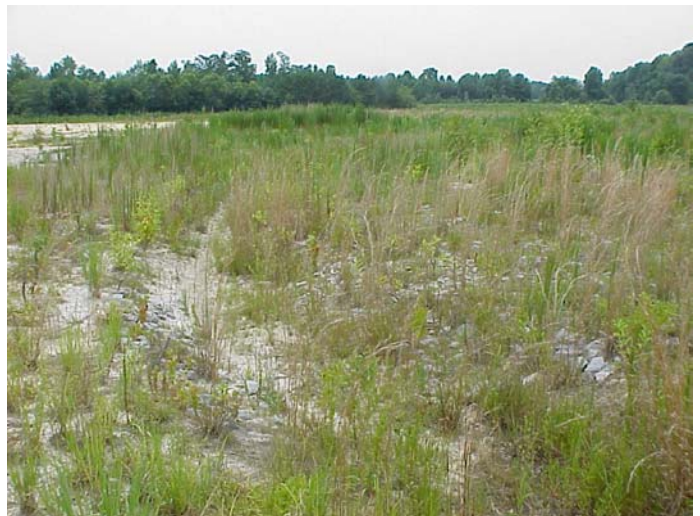
Of the 89 acres on this site, approximately 83.7 acres involved tree planting. There were 11 vegetation monitoring plots established throughout the planting areas. The 2002 vegetation monitoring of the site revealed an average tree density of 466 trees per acre. This average is above the minimum success criteria of 320 trees per acre. The stream channel was visually monitored during the annual vegetation monitoring of this site. The streambank was heavily vegetated with herbaceous vegetation and stabilized in all areas except where matting was not installed. Photos 11 through 24 show the conditions of the stream.

Based on a field meeting in May 2002, the main stream thread revealed a small “head cut” near the culvert discharge location at US 264. Upon agency request, a follow-up meeting was held with the NCDOT Hydraulics Unit to determine the cause and to develop a proposal for remediation. In August 2002, a follow-up meeting was held to discuss the NCDOT proposal with the Corps of Engineers and the Division of Water Quality (DWQ). At that time, the DWQ requested a survey of the stream in order to justify the proposal. NCDOT also scoped KCI, the stream/ wetland designer, to survey all stream threads, as well as reference their reaches. This work is currently underway. Upon completion, a meeting will be scheduled with the regulatory agencies to reach a consensus on a remediation plan.
